Superfish Run - Feb. 28, 1997

ANTENNA ASSEMBLY FOR X-RAY RING RF CAVITY 3

ANTENNA ASSEMBLY FOR X-RAY RING RF CAVITY 4

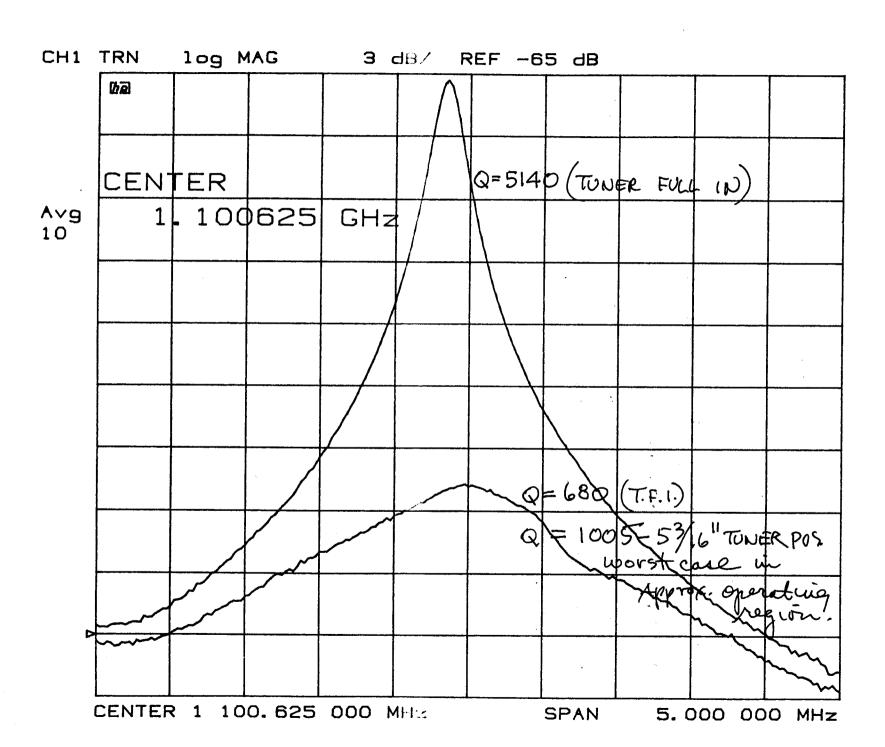
3/26/98

All probes installed and terminated Cavity temp - ambient cavity vac - N2

Input loop installed 3:1 + connected to test sys. emacamp.
Tuner position - full in

sweep = transmission measurement exciting gap w/ probe showing effect of terminated & probe #
